**National
Transportation
Safety Board**

NTSB Update: Maintenance- Related Accidents

Accident: Beech 36

Accident: Eurocopter AS 350B2

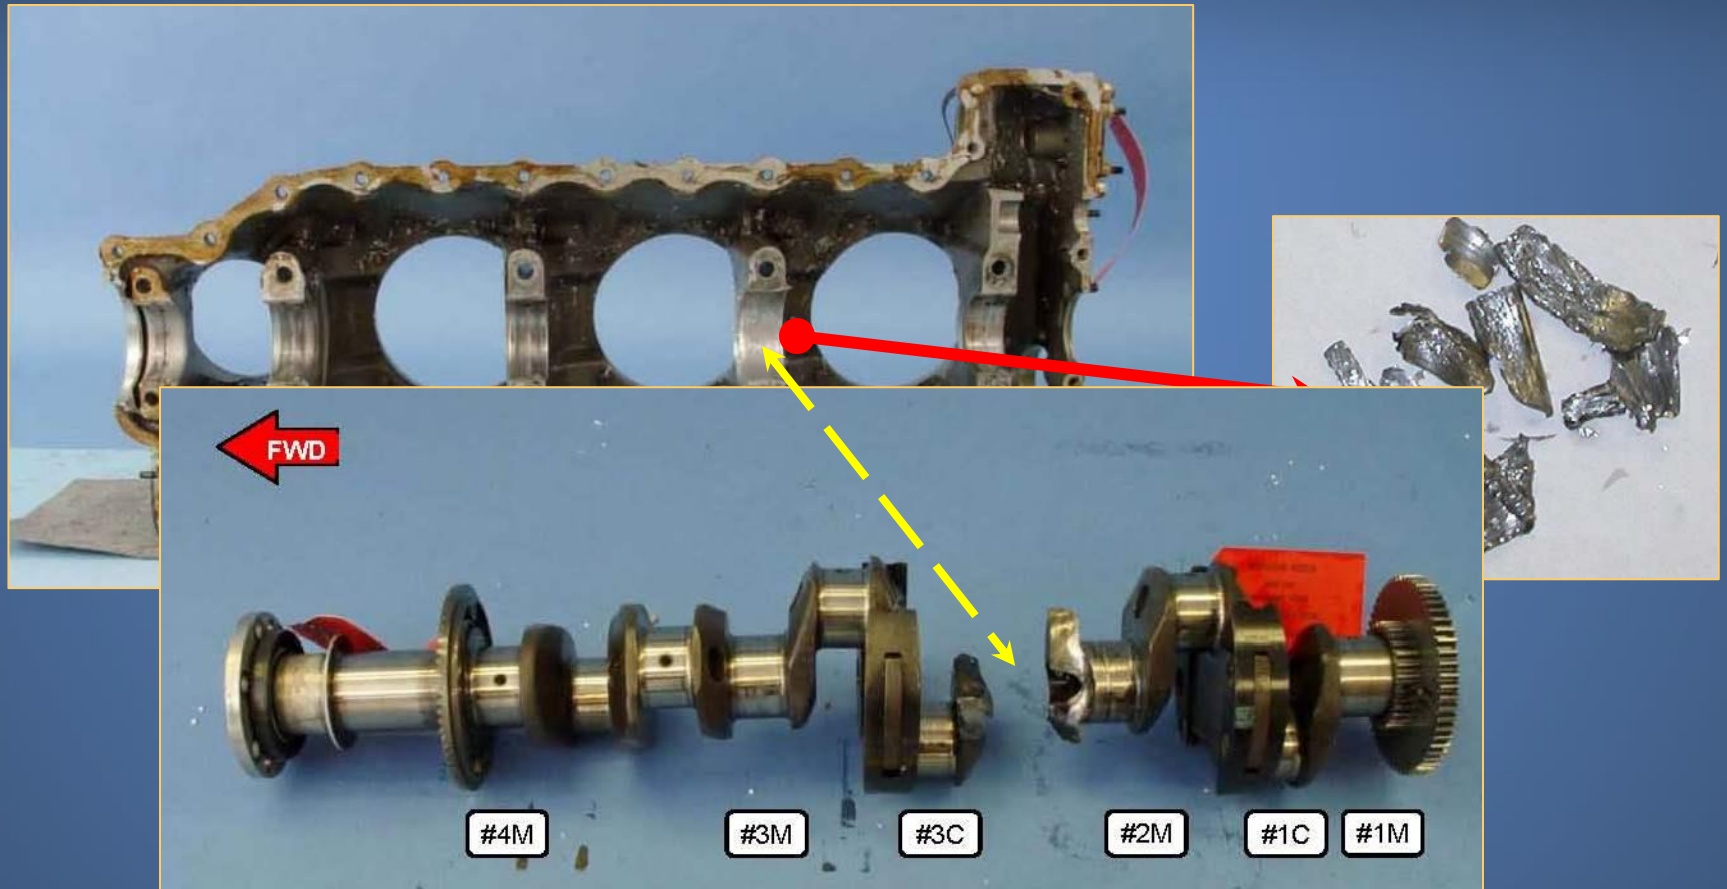
Engine Examination

- No outbound leg problem reports
- Return leg: midnight taxi out, return to FBO to request mechanic (unavailable until morning), so pilot departed – IFR
- Complete loss of power 9 miles from destination, night IMC forced landing on a golf course
- Engine examination: crankshaft fracture

- Evidence of gasket-making material, silk thread on main bearing bosses
- TCM Service Information Letter (SIL) 99-2B discusses case threading

- Follow manufacturer's instructions
- Use up-to-date materials, ask questions if unfamiliar
- Best practices for human factors:
Eliminate fatigue, pressures, etc.

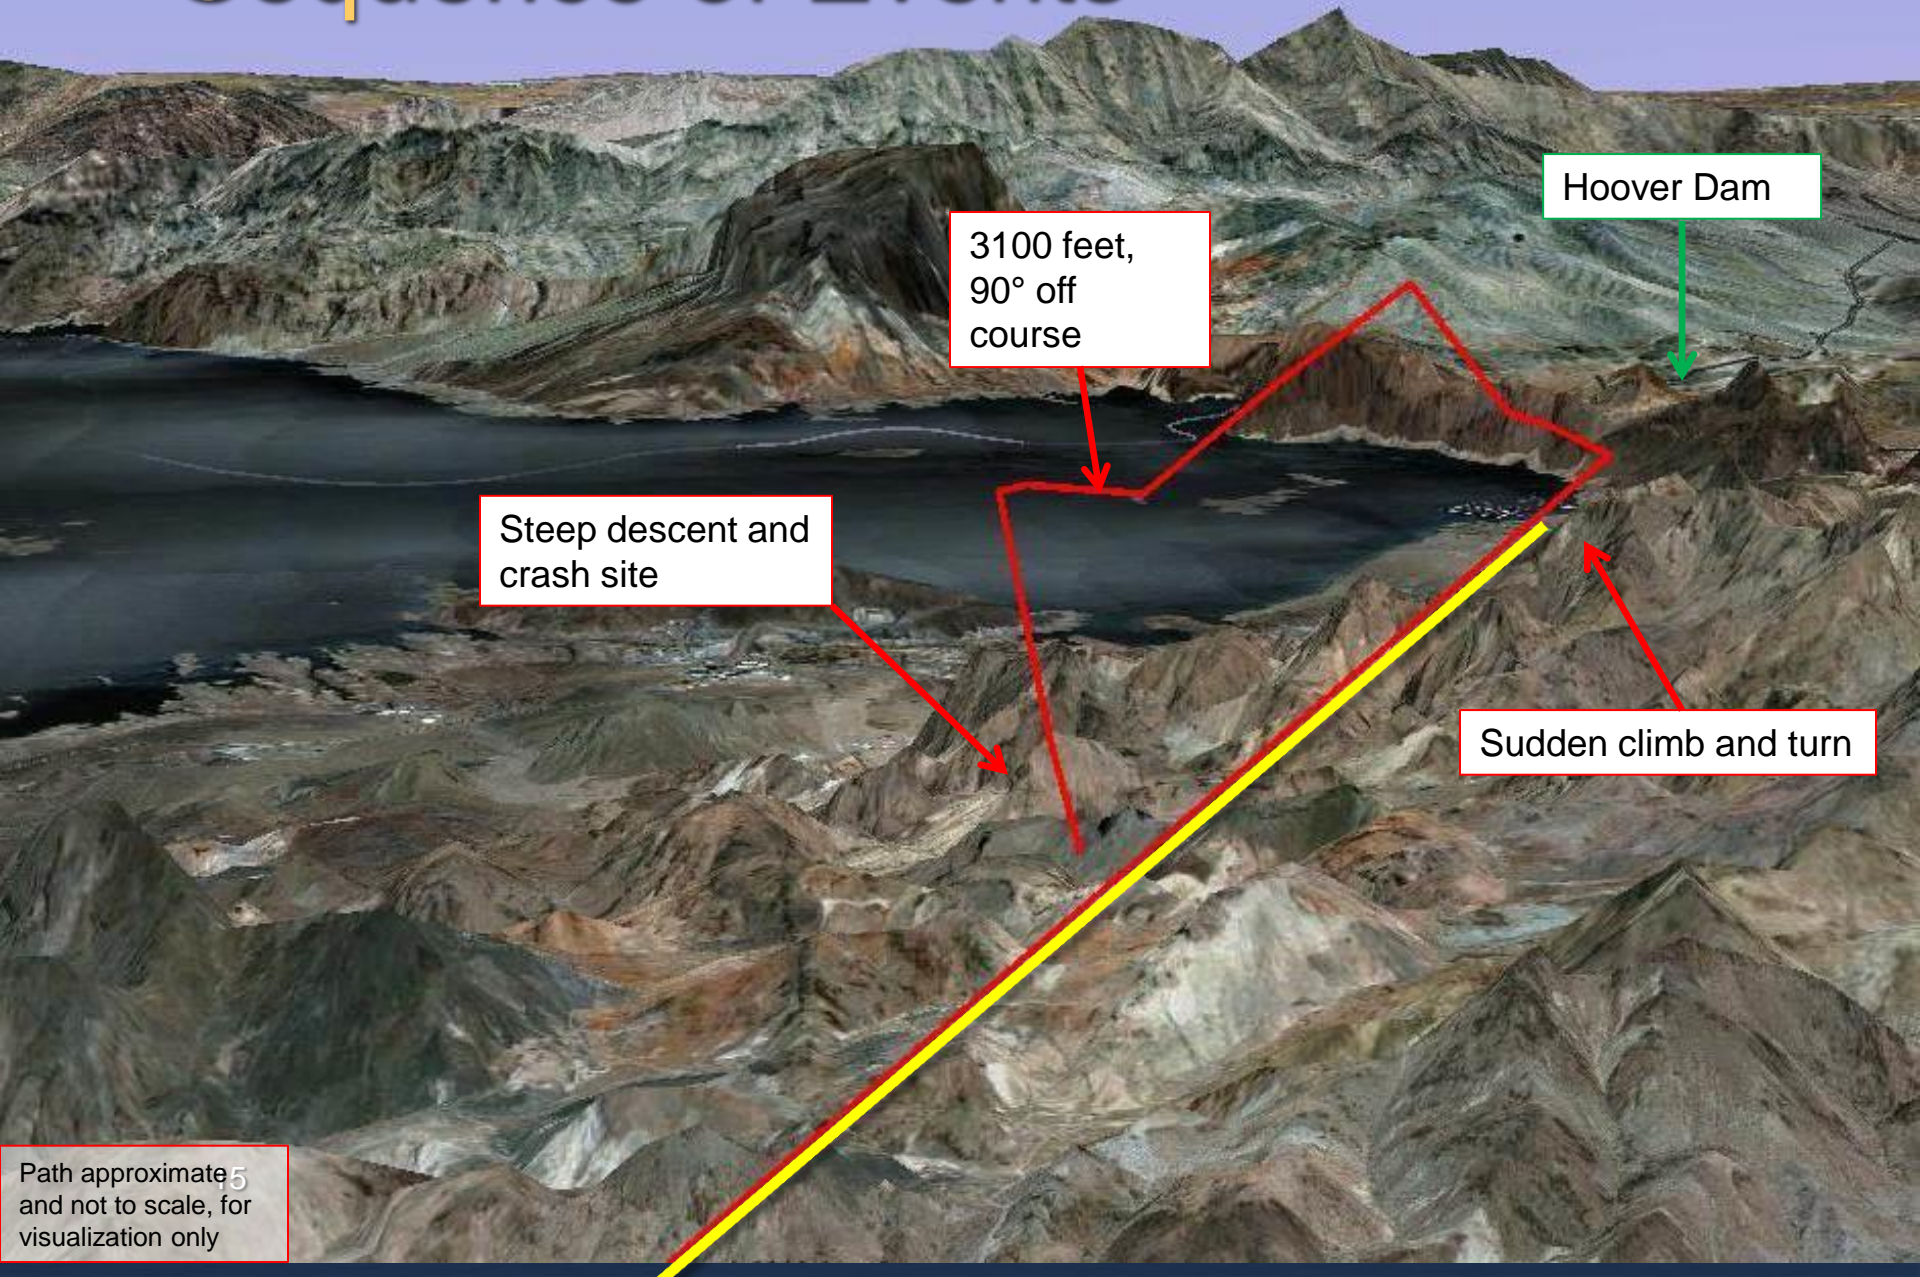
Sequence of Events

3100 feet,
90° off
course

Steep descent and
crash site

Sudden climb and turn

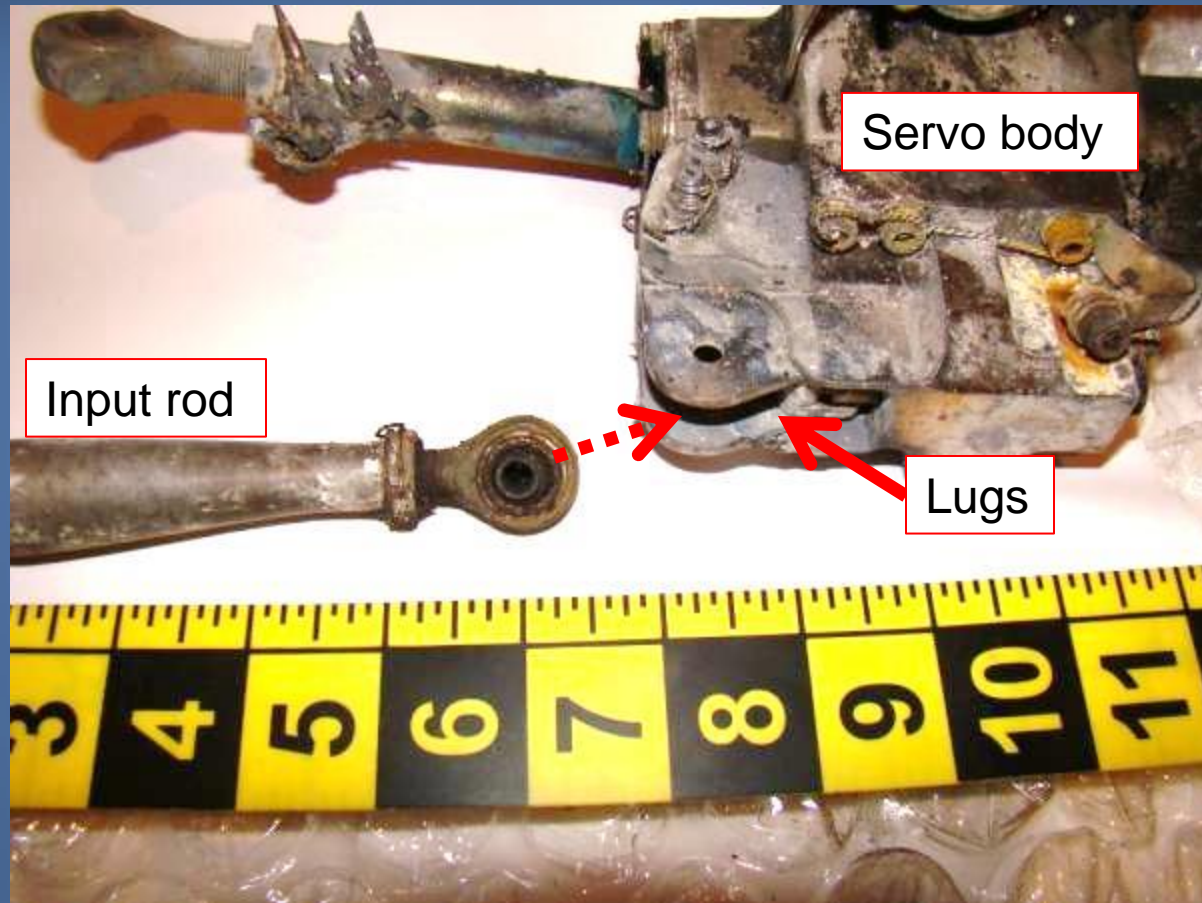
Input rod and servo

- No evidence of non-standard flight
- No evidence of bird strike
- Altitude clear of terrain/obstacles
- Weather not a factor
- Fore/aft servo disconnected

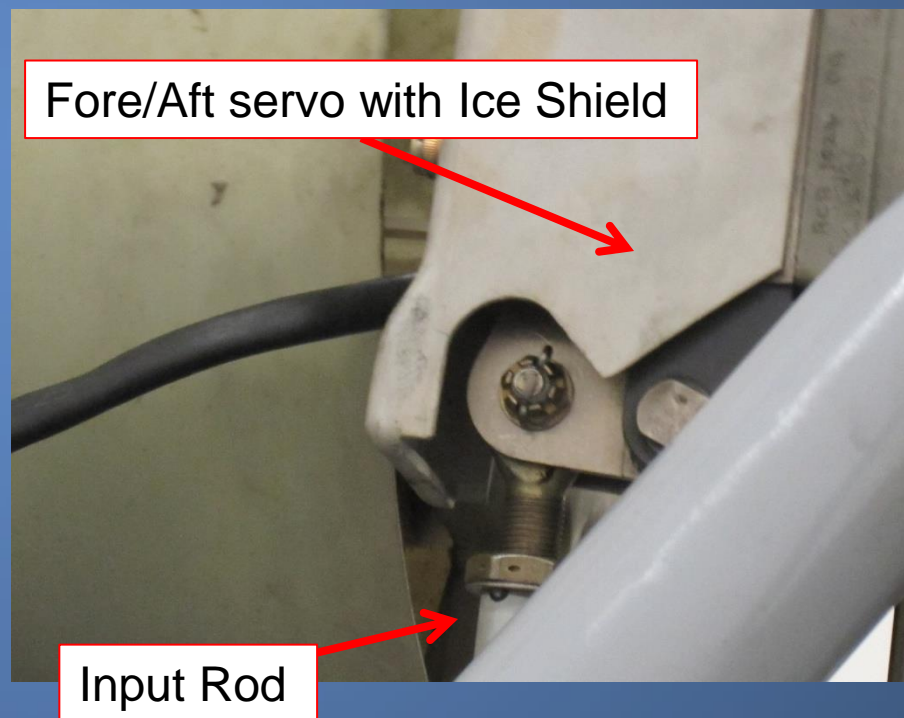
Hardware installed

- Two locking devices
 - Self-locking nut
 - Cotter pin
- Self-locking nut most likely became separated from bolt

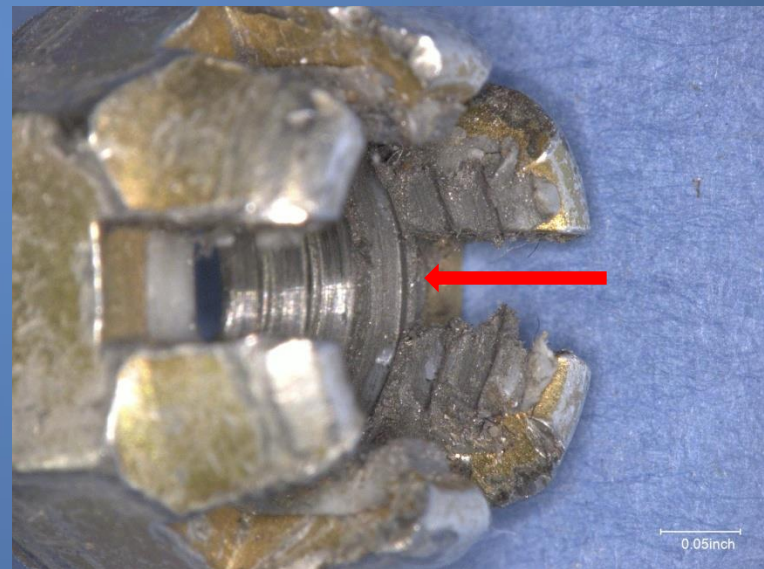
Degraded Nut

- Manufacturer's guidance: "If a nut can be easily tightened, it is to be discarded"
- FAA guidance: "DO NOT reuse a fiber or nylon lock nut if the nut cannot meet the minimum prevailing torque values"
- Fleet inspection of 13 helicopters: Half of self-locking nuts did not meet requirements

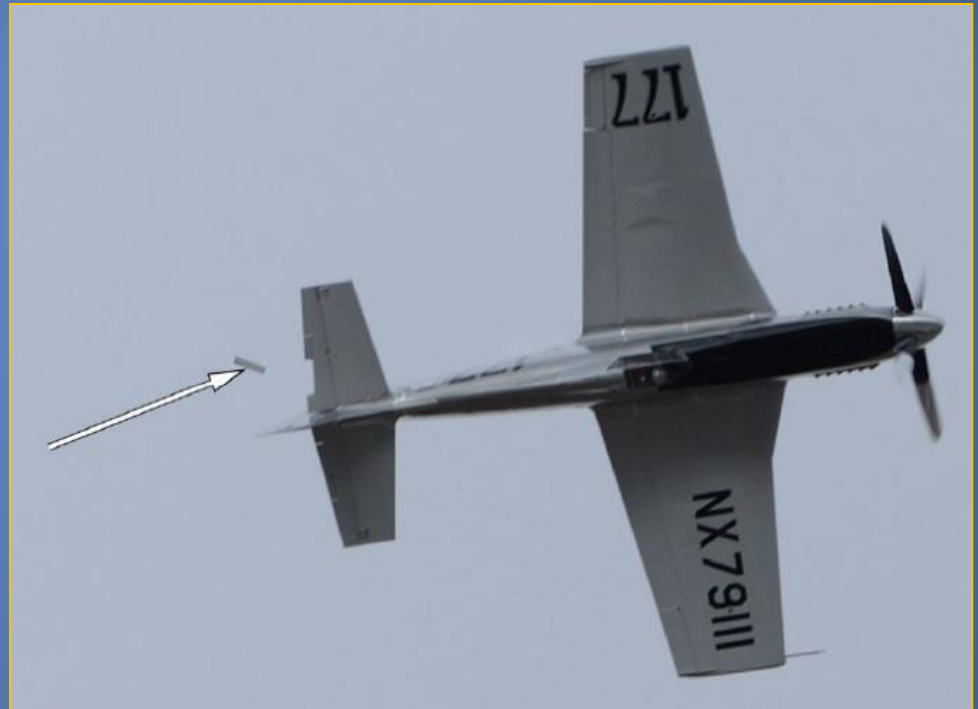
Deteriorated self-locking nut was one “link in the chain” of P-51D crash in the 2011 Reno Air Races (note separated elevator trim tab)
